Mainstreaming Climate Change Risk Management in Development

1 Main Consultancy Package (44768-012)

ROADS AND BRIDGES SECTOR DoR

MYAGDI VULNERABILITY ASSESSMENT REPORT

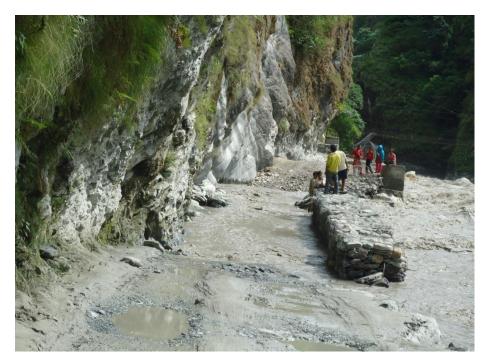
Fig.4a Damaged section of the road at km 17. The damage occurred due to extensive bank erosion by Kaligandaki River. At present, DoR is constructing gabion wall to protect the road from river damage.

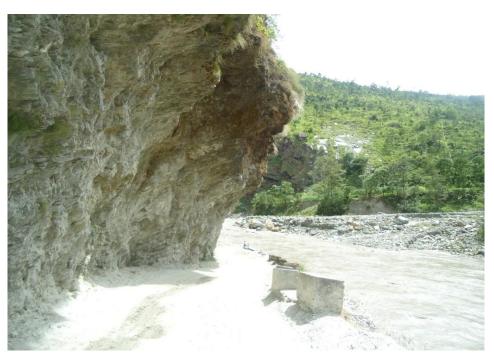
In July 2012, Sunari Khola which joins the Kaligandaki River at km 17, transported large amount of debris. The debris obstructed the waterway of the Kaligandaki River at right bank. Due to obstruction at right bank, the river hit the left bank and severely damaged about 100 m long section of road. DoR, at present, is constructing retaining walls to protect the road and maintain the vehicular traffic (see photo).

Fig.4b At right side of the photo, the heap of gravels and boulders is the debris deposited by Sunari Khola in July 2013. The debris pushed the River towards left bank and severely damaged the road.

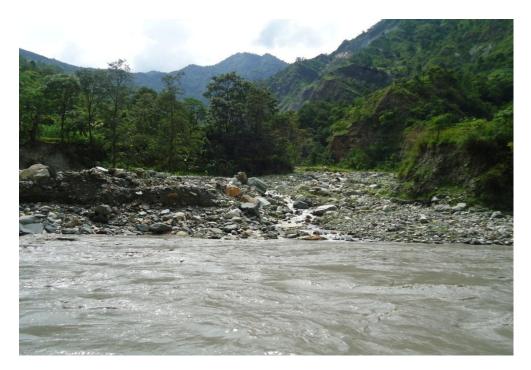
Fig. 4c View of debris deposited by Sunari Khola from the road. According to the district technicians, the bed level of the Sunari Khola was raised by 2-3 meter after debris deposition.

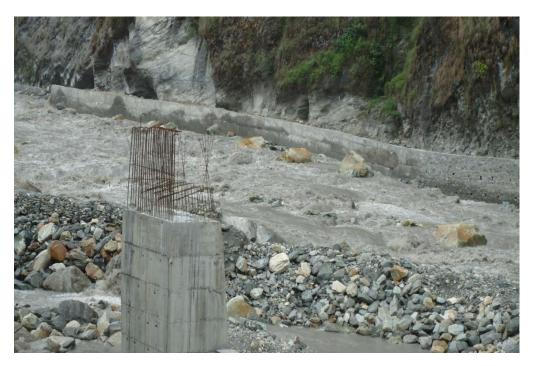
Fig. 4d: Photo of newly constructed wall to protect the road which is located at left bank. The photo is taken from right bank. DoR has already constructed about 100 long stone masonry/concrete protection walls and reconstructed damaged road section. DoR is constructing a motorable bridge near the damaged road. Right abutment of the bridge is also seen on photo.

- 4. Bank protection works are very near to the main river course. They were damaged several times in the past;
- 5. The section of the bank protection works is adopted from typical design and cannot withstand impact due to higher flood. Damage/collapse of bank protection works will wash away the road causing traffic closure for several days.

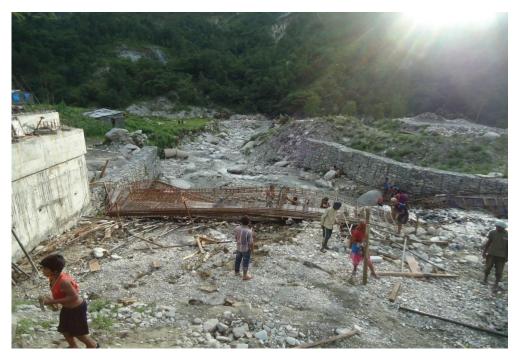
In the mean time a flash flood occurred on the night of June 10, 2013 and washed away all the formworks and reinforcements. When the consultant visited the site, the contractor was collecting and stockpiling the formworks and reinforcements. Due to this incident the schedule of concreting of superstructure was delayed by about 3 months (after monsoon).

Fig. 5a: View of the bridge after the flood washed away formworks, struts, and reinforcements. Upstream view of the khola is also seen on photo. The photo was taken after 3 days of the event. As seen on photo, the khola has already dried up.

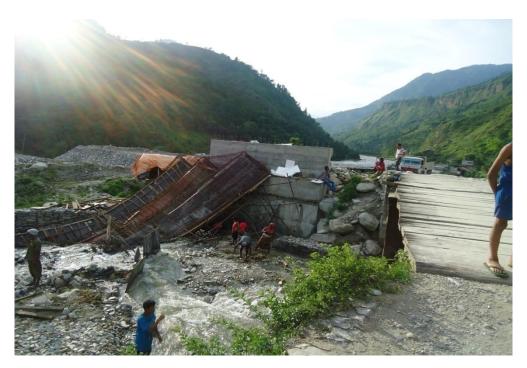
Fig. 5 b: The labours are stock piling the formworks and reinforcements which were washed away by the flood. The concrete abutment at right side which was recently completed can be seen on photo. The condition of both abutments is good.
