TA 7984: MAINSTREAMING CLIMATE CHANGE RISK MANAGEMENT IN DEVELOPMENT

Identification of high risk projects

Prepared by: ICEM

Prepared for: Asian Development Bank and Ministry of Science, Technology and Environment, Nepal

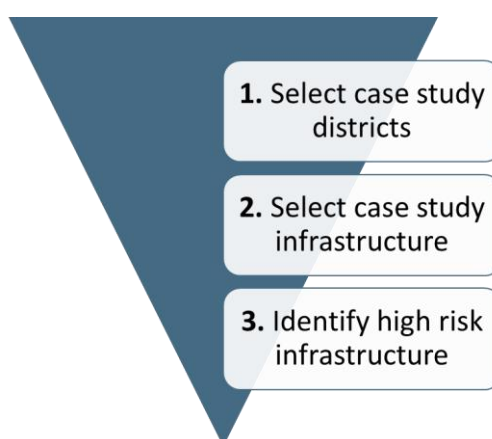
Figure 2-1 Process for identifying high risk projects

With seven sector departments and hundreds of projects being implemented by each department a phased approach was selected to identify high risk projects. High risk projects in each department’s portfolio were identified through three phases with each phase decreasing the number of projects under consideration (Figure 2-1). The approach does not necessarily identify the most high risk projects in each department’s portfolio, but provides a snapshot of the types and locations of projects that have high risk. This can assist the departments in prioritizing where adaptation funds and efforts are best placed geographically and technically.
